Landslide occurrences in the hilly areas of Bududa District and their causes.

Kitutu Kimono Mary Goretti,
Environment Information Systems Specialist.
National Environment Management Authority.

PhD Thesis.
Department of Geology,
Makerere University,
March 2010.

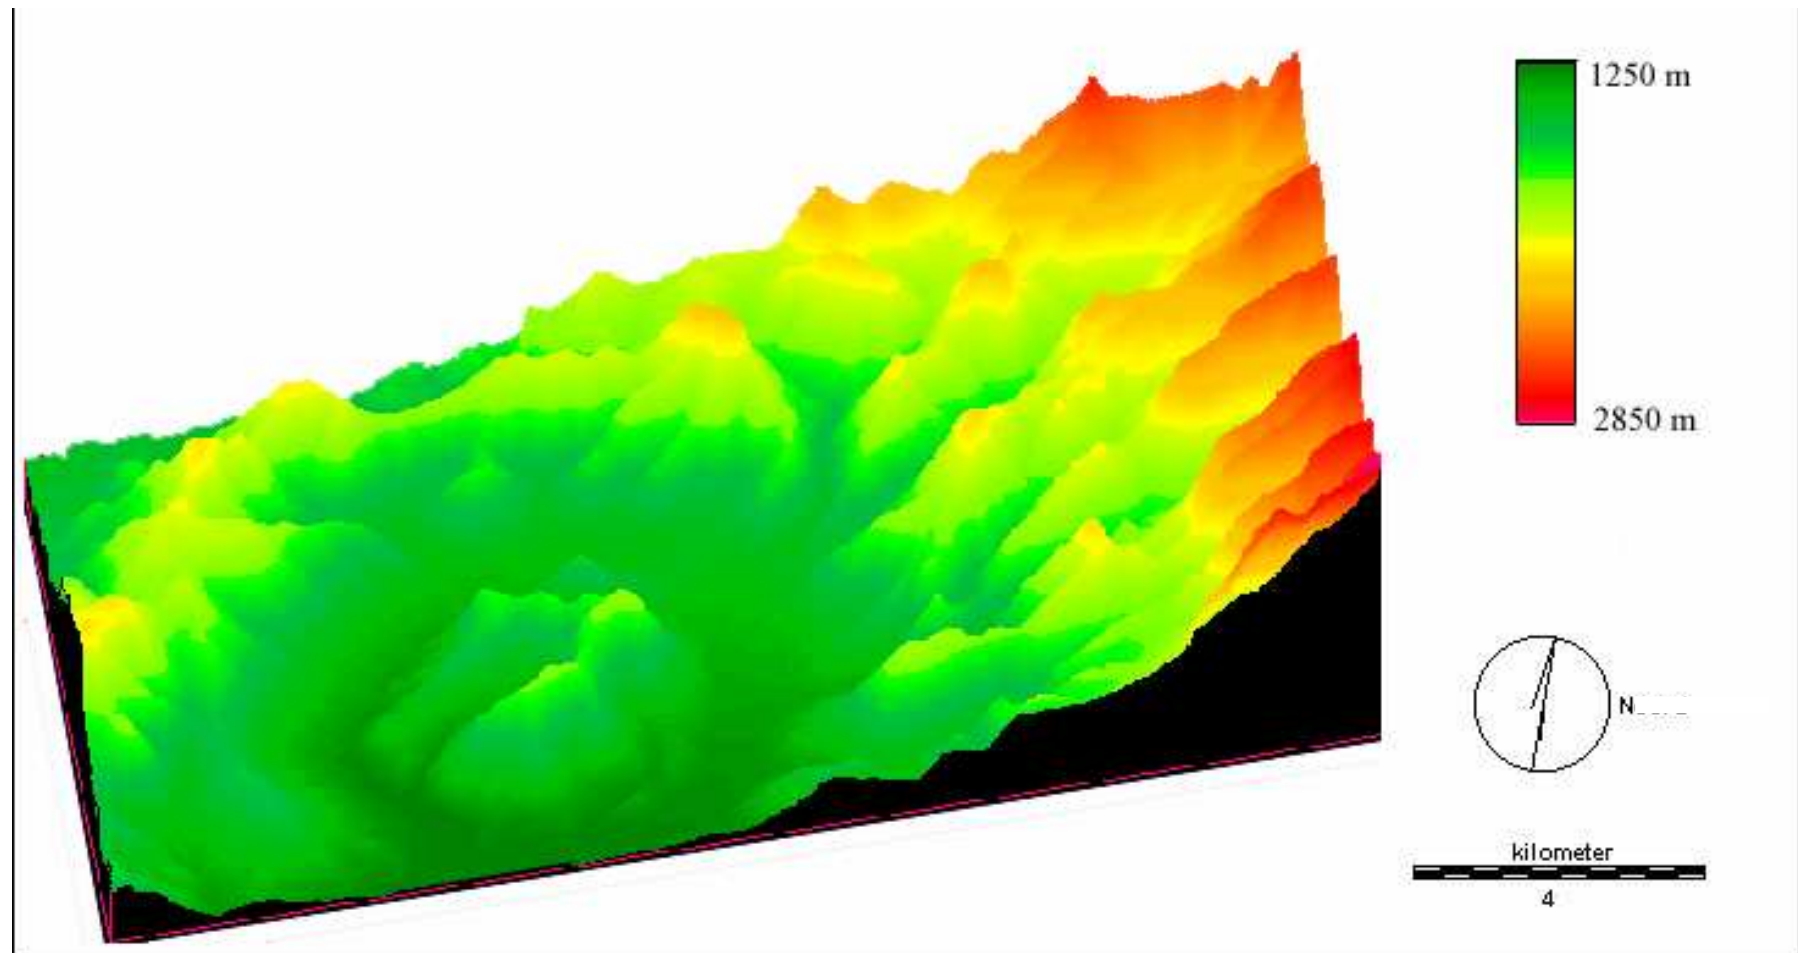
Geology

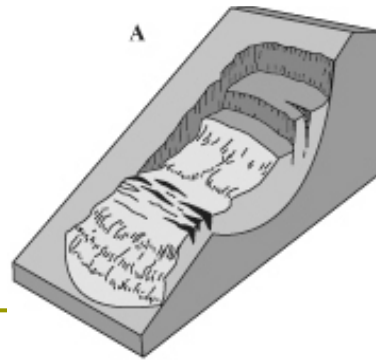
Rotational landslide

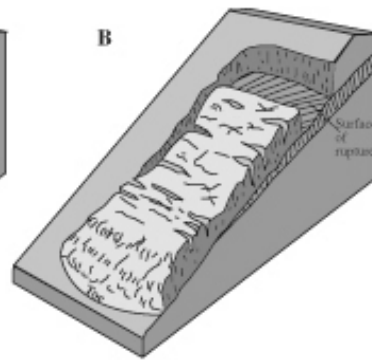
Translational landslide

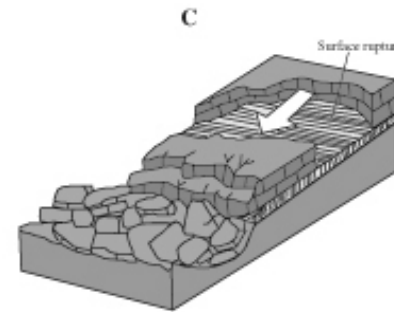
Block slide

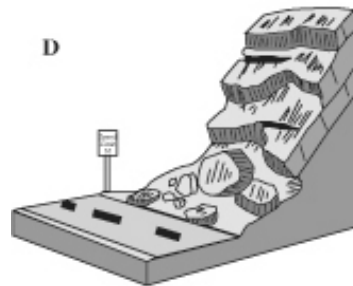
Rockfall

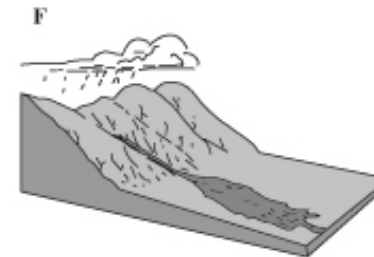
Debris flow

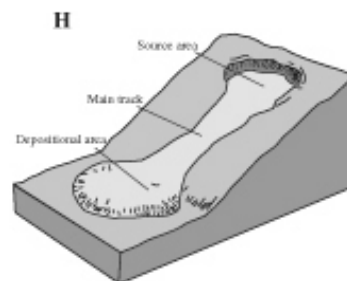
Earthflow

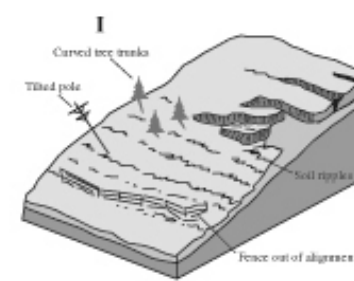
Creep

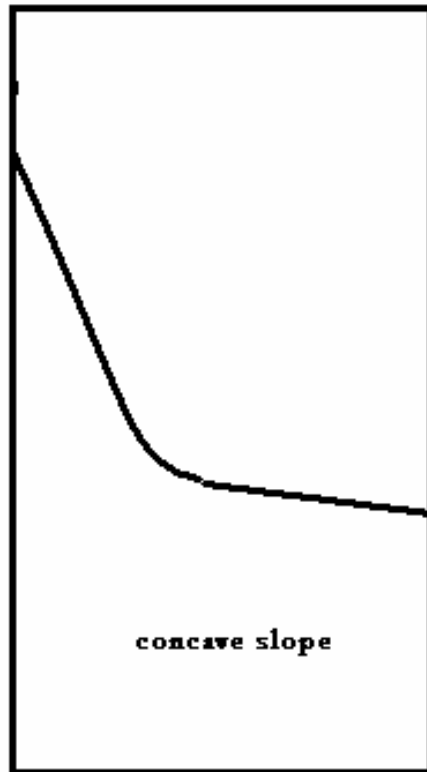
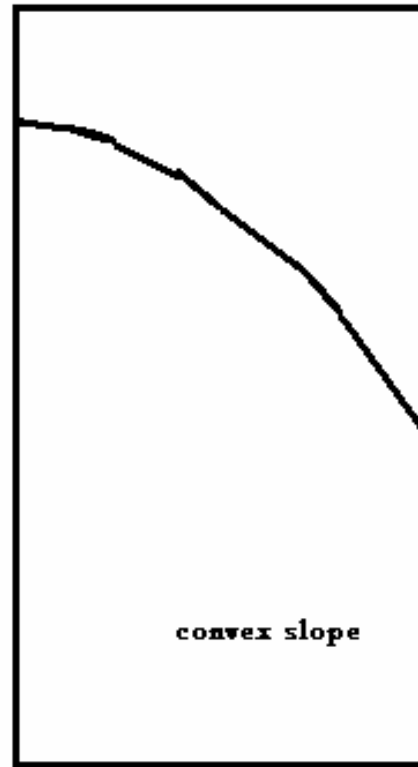
Factors that influence the type of movement.

- ▣ Landslides occur on concave slopes.

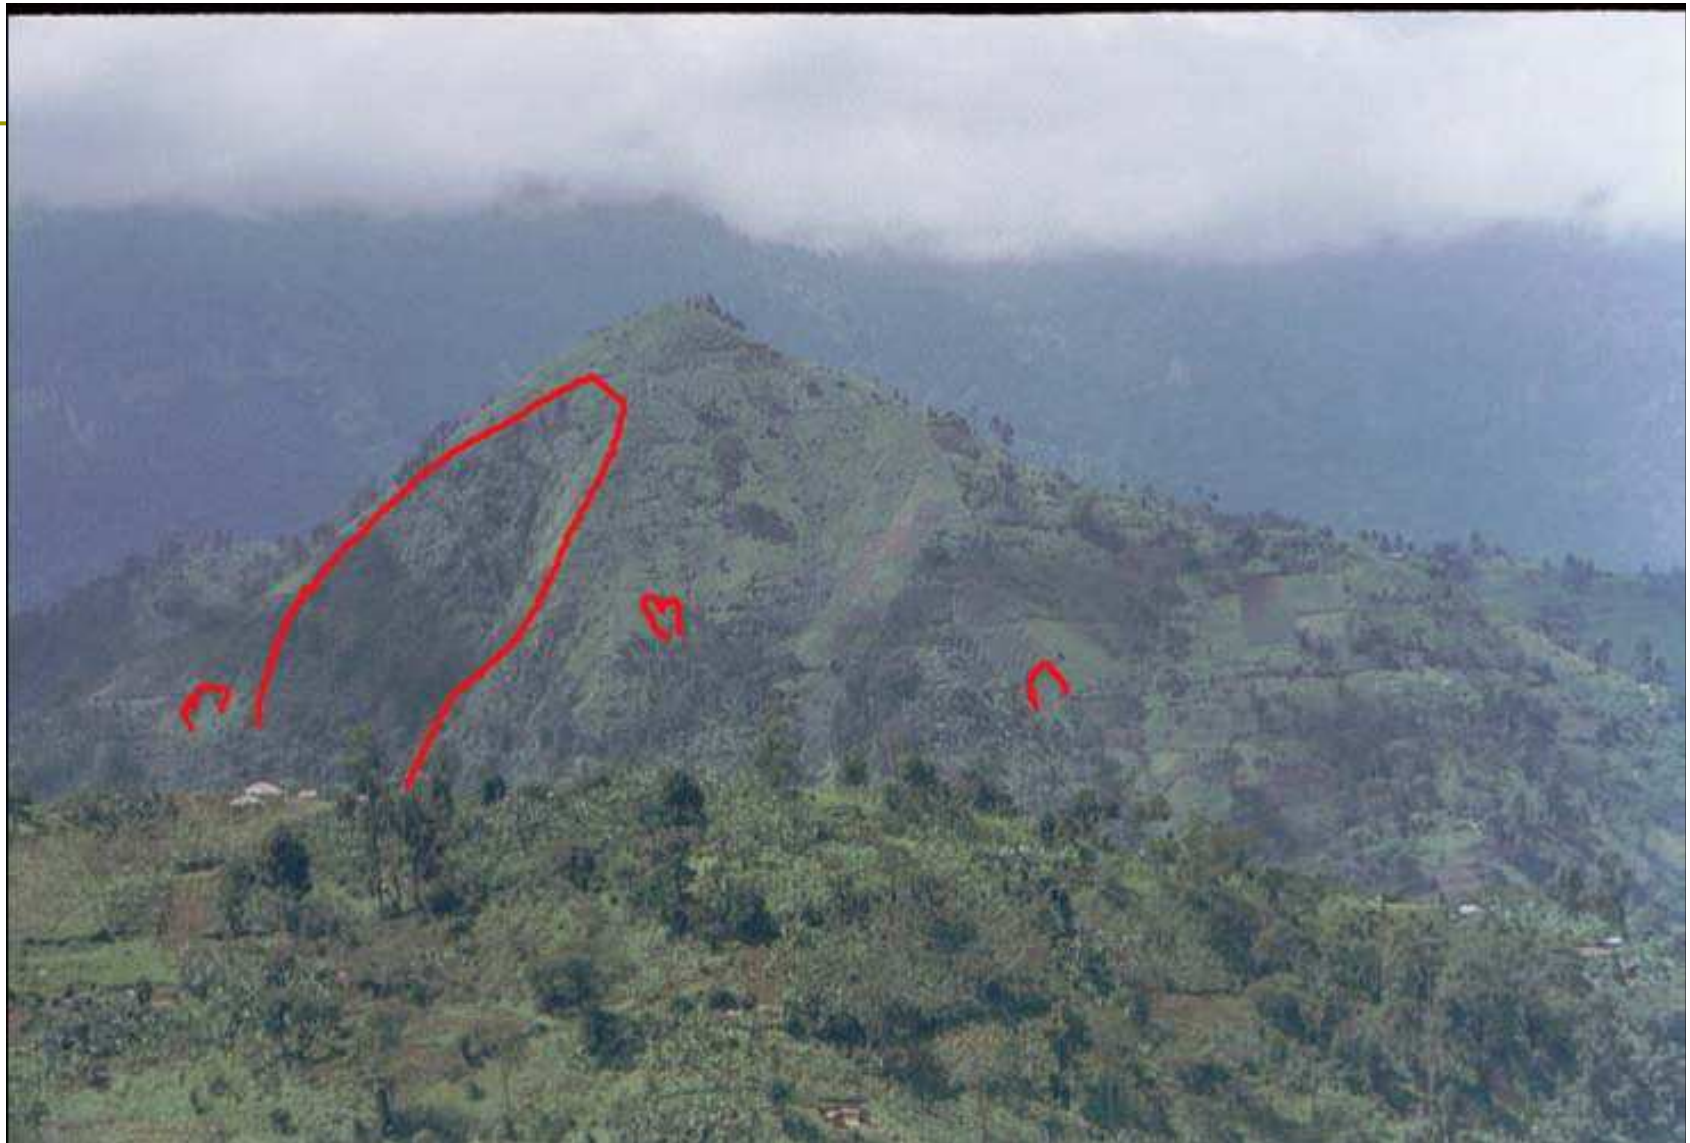
Geomorphic Impacts

- ❑ 98 of the landslides displaced 11 million m³ of material.
- ❑ 29 of these landslides dammed rivers and caused damage to bridges and roads when the dams broke.
- ❑ All bridges were destroyed in 1997.

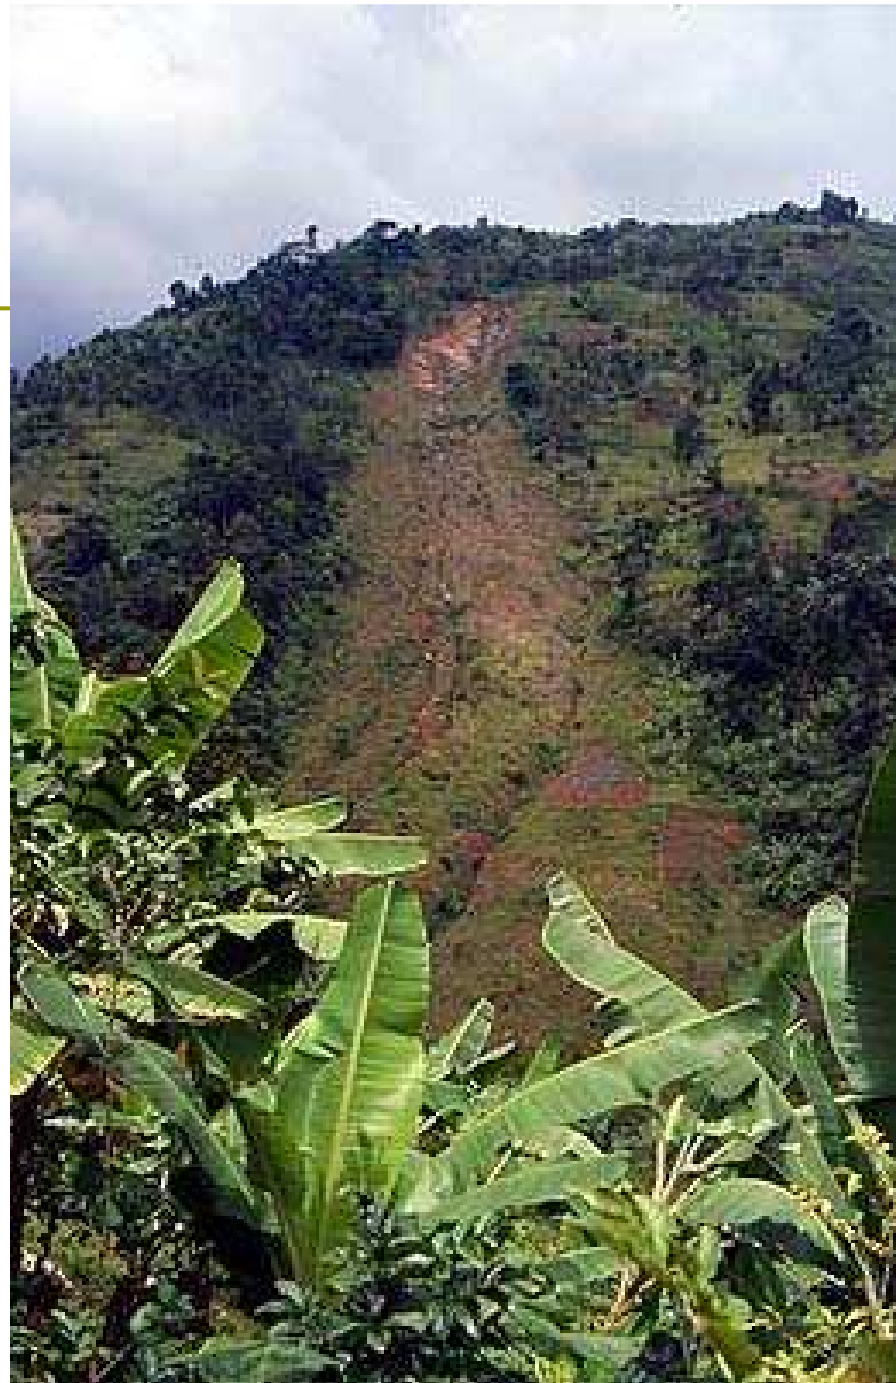
Topographic factors

Landslides occur between 14° to 60° .

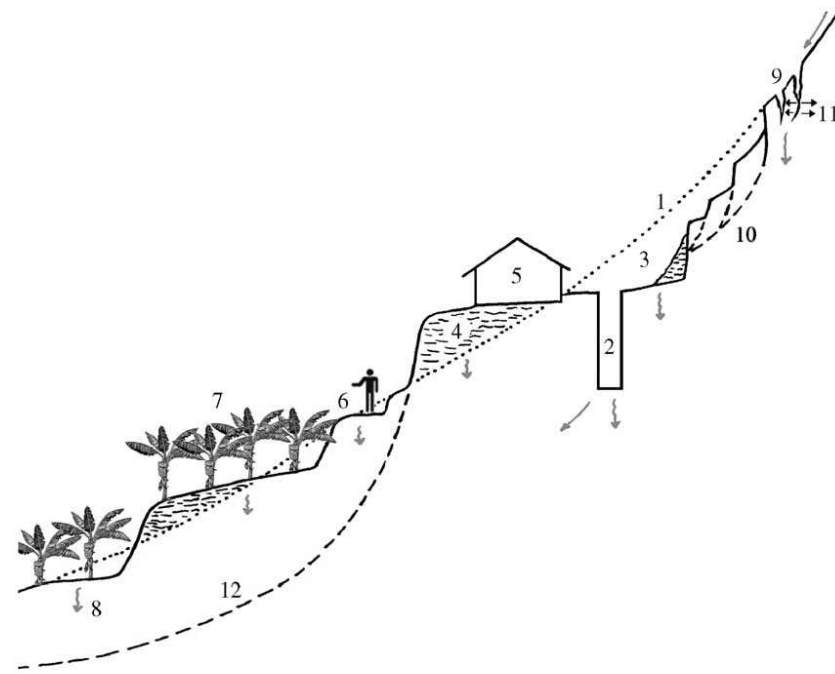
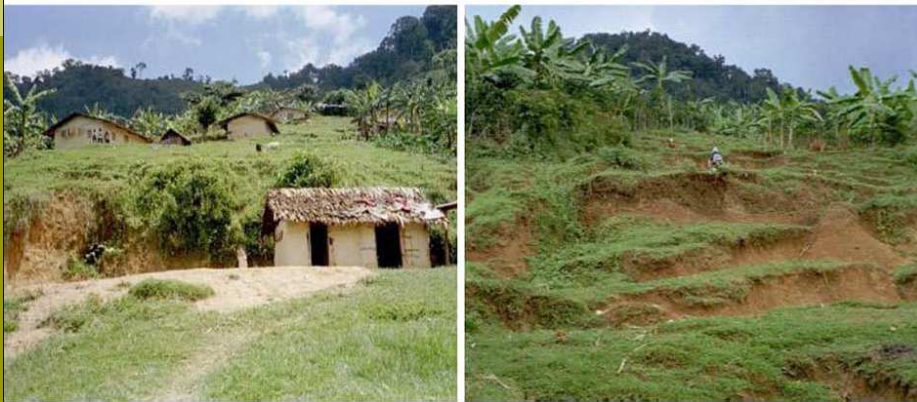
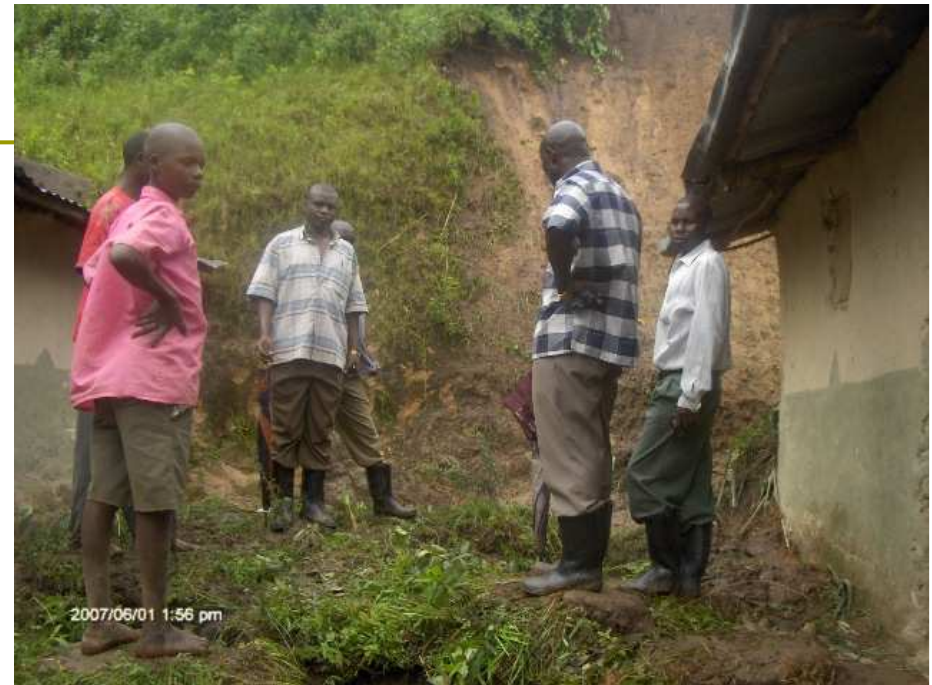
Influence of slope under cuttings

A landslide due to house construction. Two children were killed in 2007.

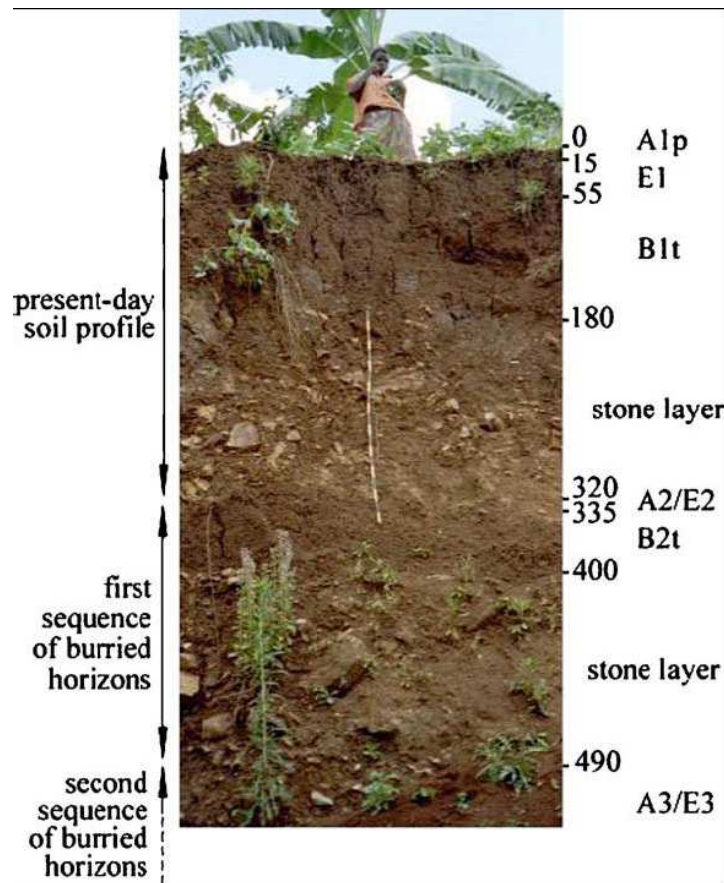
- The sequence shows buried soil profiles.
- This sequence is localised at landslide sites and is due to past landslide activity.
- The superposition of a soil horizon with a silty clay texture (52% clay, B2t) on a coarser, sandy silt loam horizon (6% clay, A3/E3) of an older soil creates a pore discontinuity that hinders drainage. Black manganese mottles on the ped surfaces of the illuvial clay horizon (B2t) are an indication of the reduced drainage.
- Landslides in western zone are due to soil horizon stratification that favors water stagnation in the lower horizons and they are only confined to places where there is water stagnation in the lower soil horizons.
- Local population confirm a cycle of 100 years.

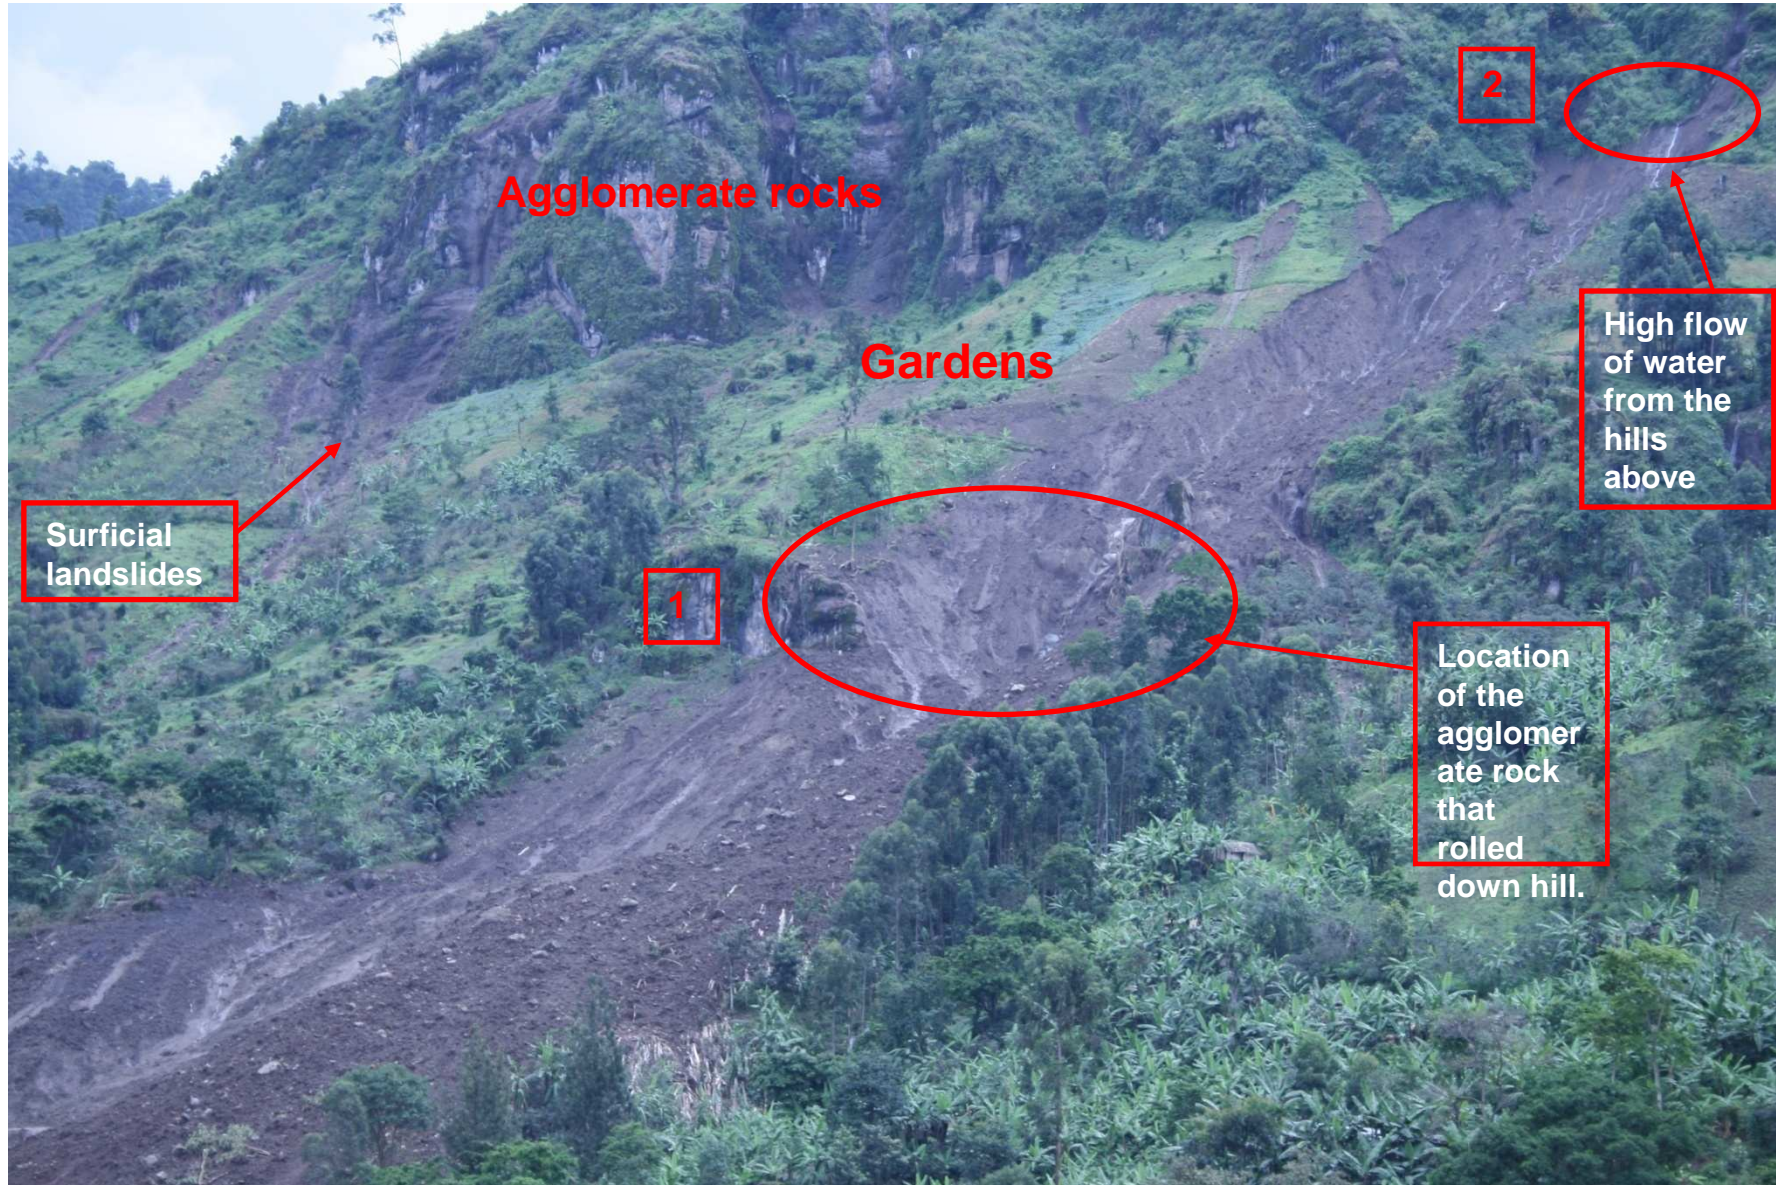
Agglomerate rocks

Surficial landslides

High flow of water from the hills above

Location of the agglomerate rock that rolled down hill.

Causes of the debris flow on 1st March 2010.

- ❑ Due to the high and continuous rainfall for five days there was concentrated water flow at **point 2**.
- ❑ This was the main triggering factor of this debris flow.

- ❑ The concentrated flow saturated the soils into fluid. This resulted in high pore pressure enough to liquefy the soils.
- ❑ Part of the rock at **point 1** gave way releasing the debris at high speeds downslope, which mobilized more material on its way down.

- ❑ The debris spread out an area of **10 hectares** and destroying everything in its path.
- ❑ The length of the debris flow was **800 meters** and its width varied between **70 to 255 meters**. The landslide was smaller at the top but it widened as the debris moved down slope.

- ❑ The depth of the scar is about 20m. A lot of water flows from the scars when it rains causing further saturation of the debris and moving it further down.

- ❑ The volume of debris displaced was **2,768,000 m³**.
- ❑ The higher slope is 67° and the lower slope is 10°.

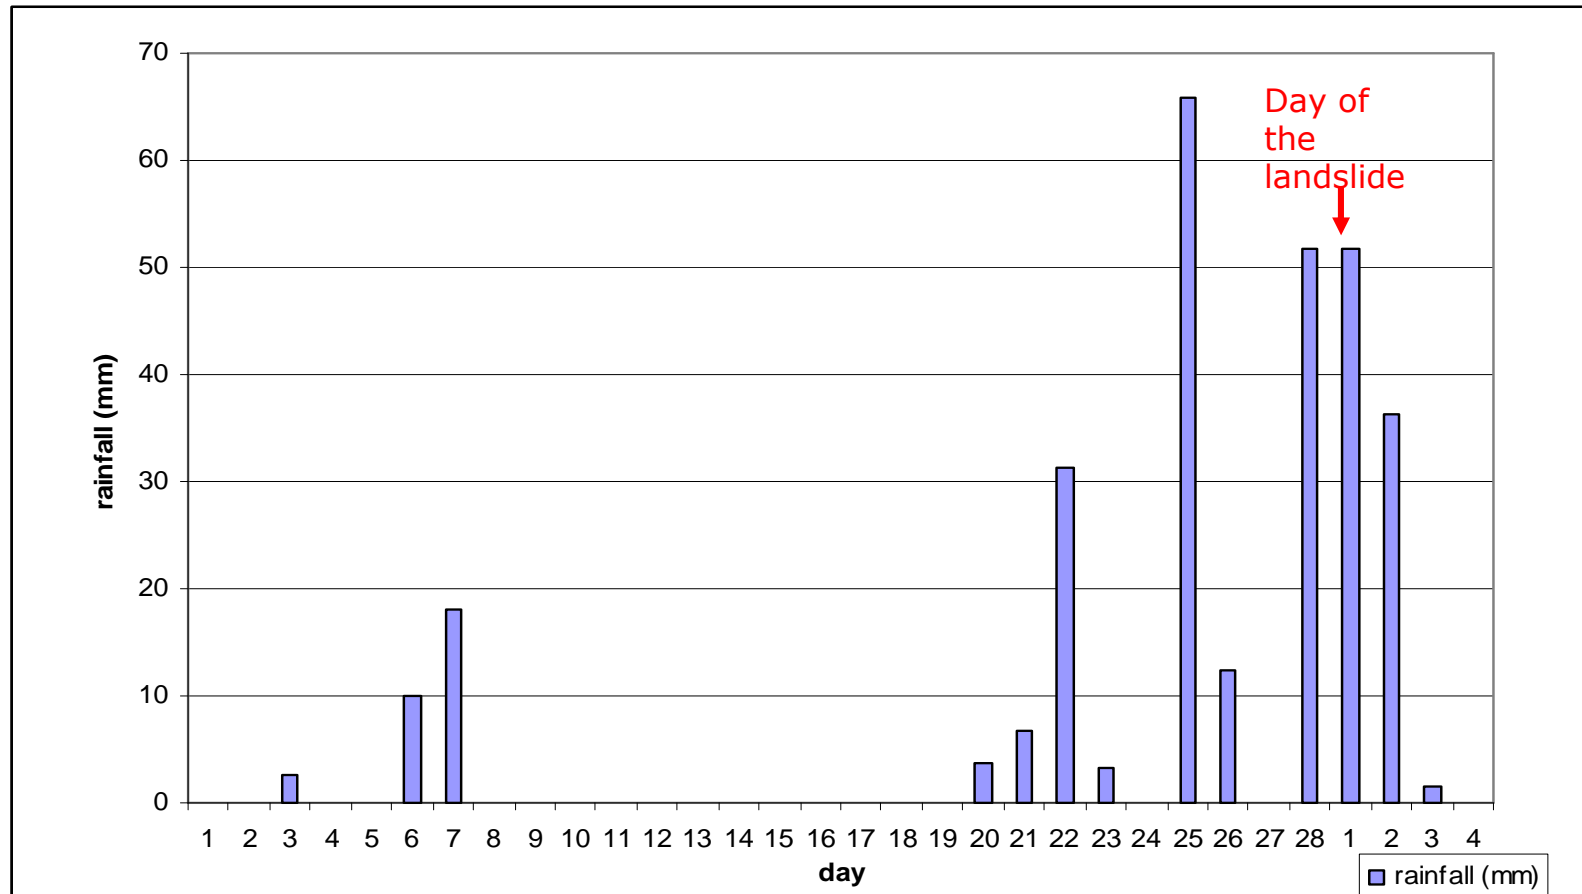
Daily rainfall for February and part of March 2010.

For debris flows that commonly develop from shallow landslides during intense bursts of rainfall.

For deep-seated landslides that are usually triggered by prolonged rainfall.
